# Marine Accident Integrated Analysis System using Highly Advanced M&S System of FSI Analysis Technique

Sang-Gab Lee, Jae-Seok Lee, Ji-Hoon Park and Tae-Young Jung

Korea Maritime & Ocean University, Marine Safety Technology, Busan, Korea

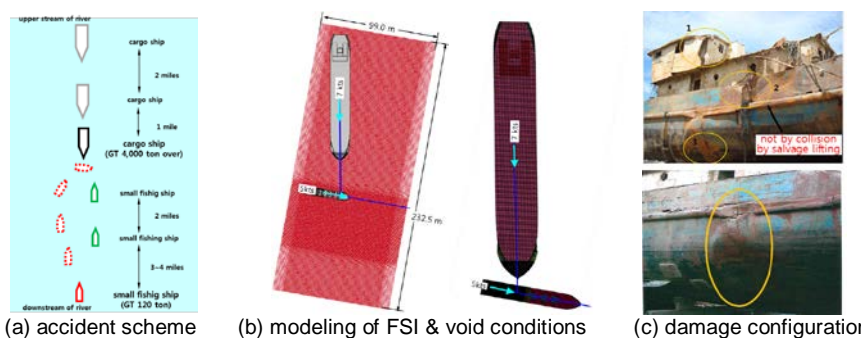
Fig.5: Scenario and modeling of full-scale ship collision &amp; sinking simulation, and damage configuration

Fishing vessel with G/T 124 ton was struck and sunk down to the bottom of river by the large cargo ships with G/T 4,000 ton and over. The collision accident occurred during cross of the struck ship to the path of the striking ships. Figure 5 shows the collision scenario and modeling of full-scale ship collision & sinking simulation, and damage configuration of struck fishing vessel. In this study, among several scenarios, one collision simulation one was considered, such as collision attack angle 80°, striking and struck ship velocities 7 and 5 knots, respectively, as shown in Fig. 5(b). For the comparison of simulation results using FSI analysis technique with those of conventional one, full-scale collision simulation was carried in void condition with the consideration of added mass, such as 1.1 times for the striking ship and 1.8 times for the struck one, where collision velocities were initial ones. Material properties of mild and high tensile steels for the striking and struck ships are summarized in Table 2.

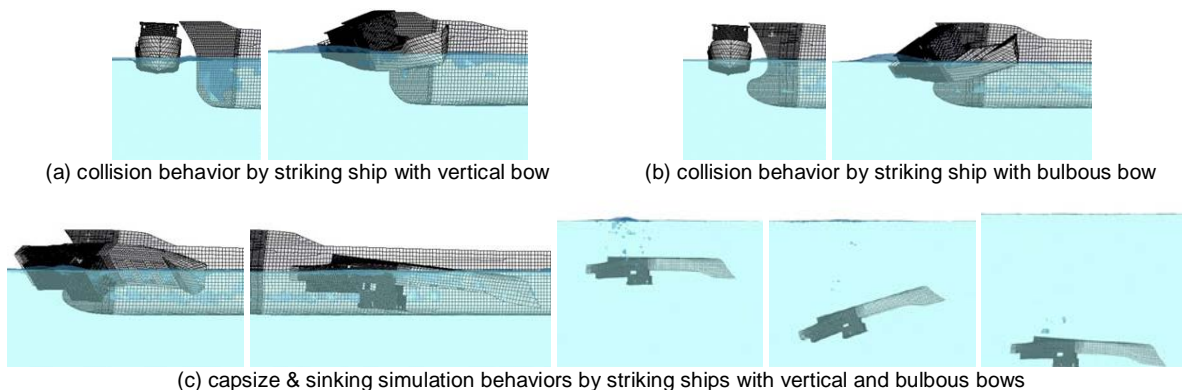
Fig.6: Full-scale ship collision, capsize & sinking simulation behaviors using FSI analysis technique

Figures 6 and 7 show the full-scale ship collision, capsize & sinking simulation behaviors and collision damage responses (stress responses) of struck fishing vessel using FSI analysis technique against the cargo ships with vertical and bulbous bows, respectively. It could be found that collision damage of struck fishing vessel looks like almost the same regardless of bow types of striking cargo ships, and that their simulation damage is also similar to the real damage one, as shown in Fig. 5(c). This is due to the fact that fishing vessel was too small to be collided to the top portion of vertical or bulbous bows of cargo ships, right after collision to the inclined bow flare, since fishing vessel was floating. Its side main deck and low side shell plate was continuously collided to the bow flare part of cargo ships, and was escaped from the their bow flare and capsized, as realistic behavior.

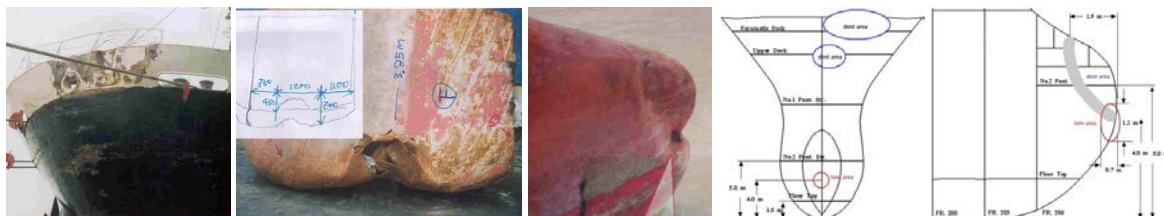
Fig. 13: Collision damage configurations and schematic damage drawings of striking ship

Striking cargo ship and struck deep-sea fishing vessel were collided on the way of typhoon evasion. The struck ship sank down after its side bottom structure was torn away by the bulbous bow's penetration of striking ship. Figure 13 shows the damage configurations and schematic damage drawings of the striking ship's forebody, and Fig. 14, of the struck ship's side superstructure and side bottom structure under free surface. From the investigation of all the collision damage informations, a collision scenario between the two ships was sketched, as shown in Fig. 15(a), where the forecastle bulwark of the striking ship hit and pushed the derrick post of the struck one at 2.75 m from the casing, and the fashion plate also pushed down the casing during the collision. Figure 15(b) depicts one collision scenario in a plan view among several ones, considering several attack angles, their speeds, and wind speeds and directions. Material properties of mild and high tensile steels for the striking and struck ships are summarized in Table 2.

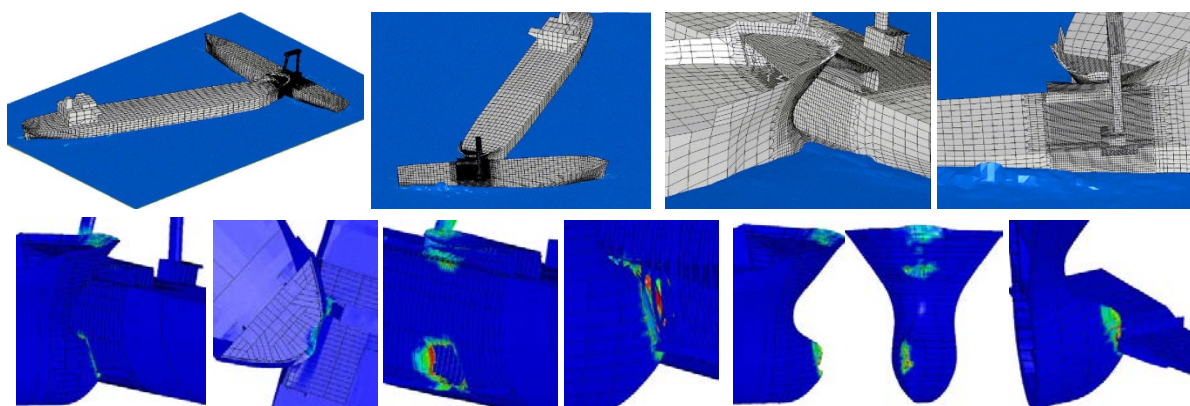
Fig. 16: Full-scale ship collision simulation behaviors & damage configurations using FSI analysis technique

Figure 16 shows the full-scale ship collision simulation behaviors using FSI analysis technique, where the side bottom structure of the struck ship was penetrated by the bulbous bow of the striking one, and was torn away with around 4.0m x 4.0m in length and height, even though the forecastle of the striking ship extends over the bulbous bow by 1.55 m. This could be possible due to a little bit turnover of struck ship by the collision of forecastle to the derrick post and the pushdown of fashion plate to the casing in the seawater using FSI analysis technique. The bulbous bow was dented by the side frame structure and the bulkhead of the struck ship, and was torn away by the strong member, the tank top structure. This collision scenario and damage configuration could be confirmed by the judgment report of KMST, as shown in Fig. 15(c).

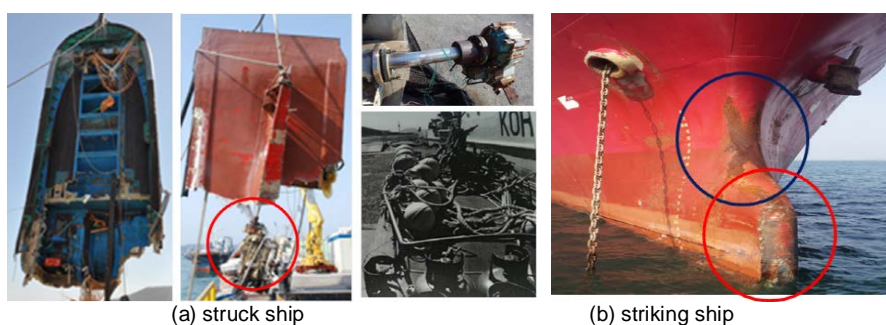
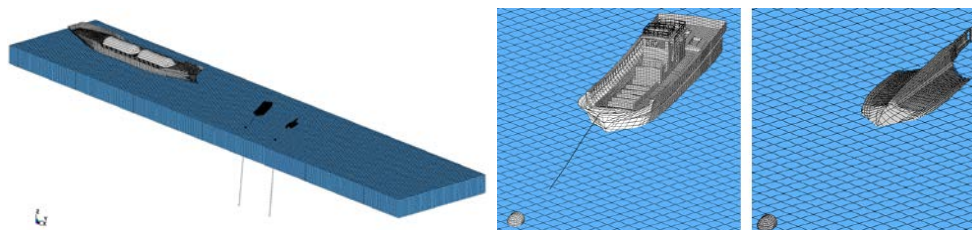
Fig. 17: Damage configurations & full-scale ship collision simulation modeling using FSI analysis technique

Small coastal grill net fishing vessel of G/T 9.77 ton was struck by a large LPG carrier with around G/T 3,000 ton during operation at night, broken in two bow and stern parts with wheelhouse upper plate, and sunk down to the bottom of river. Fishing vessel was moored with riding rope of mooring post on bow deck to fishing net cable of fixed gill nets. Figure 17(a) and (b) show the damage configurations of the struck and striking ships, respectively. The engine was rotated to the right, propeller shaft was bent from starboard side to port one, and starboard guardrail on the wheelhouse upper plate was also damaged. Paint on the bow flare of LPG carrier above the bulbous bow was scratched. The objective of this case was to investigate the cause of small fishing vessel collision accident whether it was struck by LPG carrier during floating upright or turned over states using FSI analysis technique, as shown in Fig. 17(c), by careful examination of their damages and of sea weather states at collision accident, such as current, wind and wave. Table 3 summarizes the material properties of mild steel, FRP, wood and foam for the striking and struck ships.

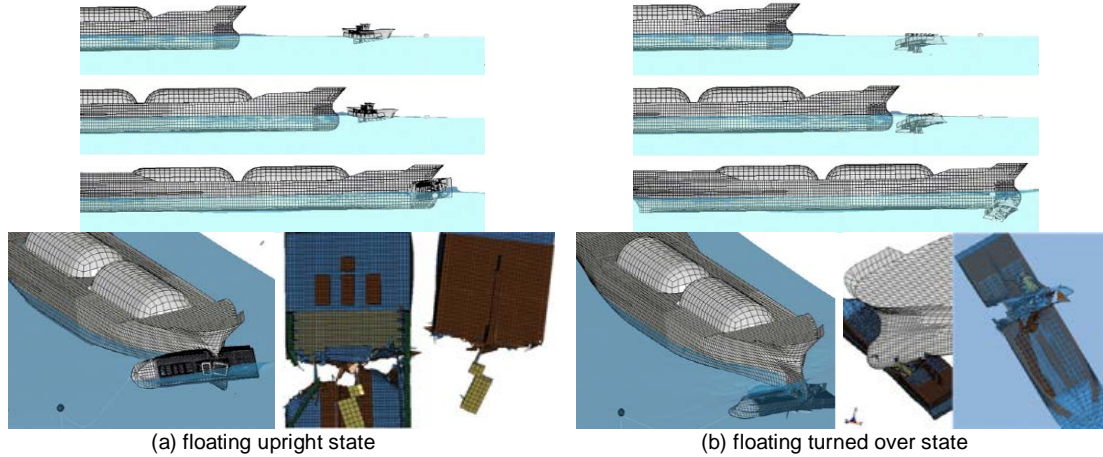
Fig. 18: Full-scale ship collision simulation behaviors & damage configurations using FSI analysis technique

Figure 18 shows the full-scale ship collision simulation behaviors and damage configurations. It could be confirmed that the fishing vessel was struck by the LPG carrier under the floating upright state from

the several damage patterns and full-scale ship collision simulation behaviors using FSI analysis technique, such as more larger size of damage fracture of starboard side compared to the port side one, starboard guardrail damage of wheelhouse upper plate, right rotation of engine and bend direction of propeller shaft from starboard side to port one, and paint scratch in the upper bow of LPG carrier, etc. All these predictions could be possible from full-scale ship collision simulation using FSI analysis technique, not in void condition.

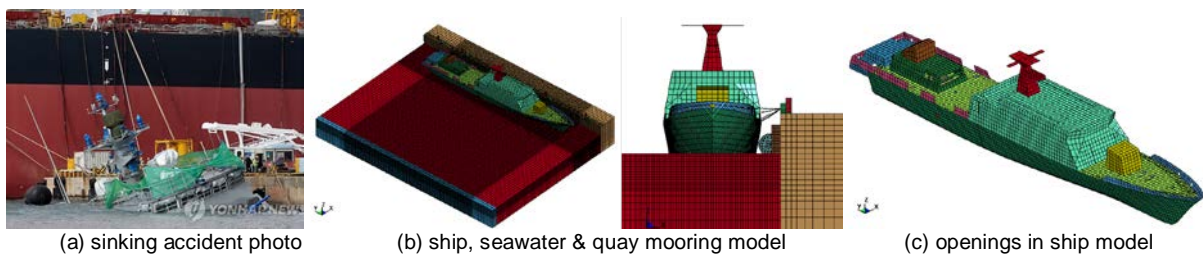
Fig. 19: Full-scale ship flooding & sinking simulation model and accident photo using FSI analysis technique

The ship with displacement 400 ton under the quay outfitting was flooded and sunk down due to the tidal breaking wave under the bomb cyclone, as shown in Fig. 19(a). Full-scale ship flooding & sinking simulation was carried using FSI analysis technique for the investigation of flooding procedure through the openings and the estimation of the flooding duration. From the marine meteorological information of the ocean data (mooring) buoy at a distance around 40.0km away from quay, significant wave height and period were 4.6 m and 8.0 sec, respectively. Figure 19(b) shows the ship and seawater model including quay, air and vertical dock fenders, ropes, etc., and the ship is floating in the seawater at the depth 7.3 m. There are many openings on the deck and superstructure, and in the watertight bulkheads, as shown in Fig. 19(c).

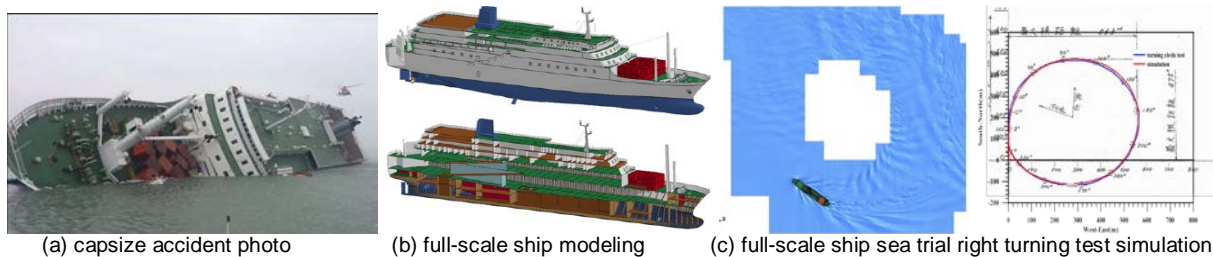
Ro-Ro ferry ship was capsized and sunk down to the bottom in the seawater around Jindo-gun, as shown in Fig. 25(a), due to the rapid turning with several reasons, such as gravity rise due to excessive extension and rebuilding of stern part, lack of stability, shortage ballast and excessive cargo loading, excessive outward heel due to small GM during rapid turning, and cargo leaning according to lateral heel angle due to poor lashing, etc. Objective of this study is to investigate the initial stage of capsized accident cause at present using highly advanced M&S system of FSI analysis technology through the verification of full-scale ship turning simulation by comparison with maneuvering performance sea trial test result of initial building ship, as shown in Fig. 25(c).

(a) capsized accident photo

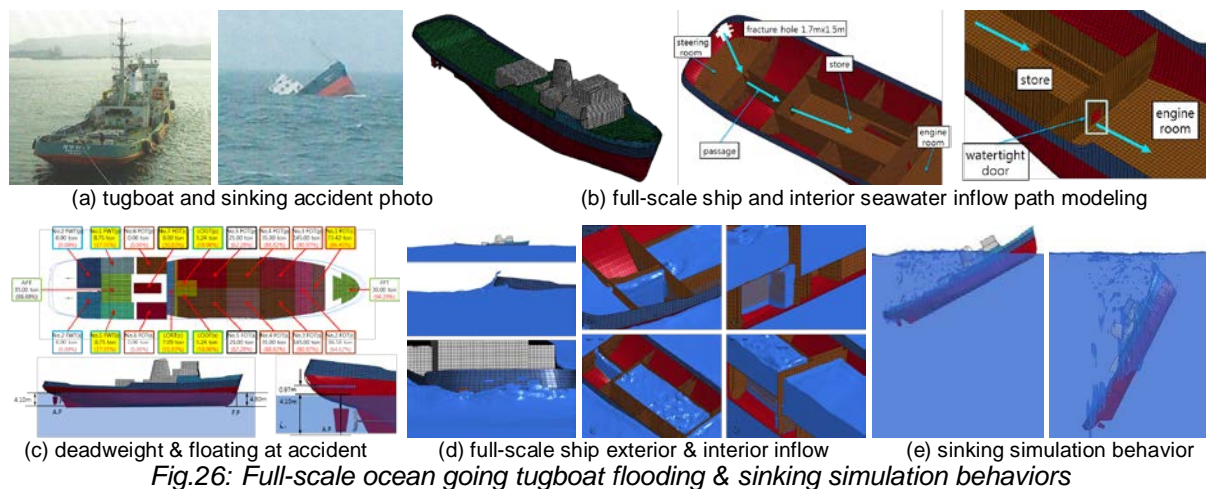
Ocean going tugboat was fully flooded in the engine room with tearing puncture damage by the collision of 3 hold barges to the rear left steering room and steering gear failure, was sunk down without clear reasons in the sea during drift at the local time 8:15 in the morning, as shown in Fig. 26(a). Full-scale ship and interior seawater inflow path modeling, as shown in Fig. 26(b), and prediction of each tank and compartment volume were conducted by floating simulation using FSI analysis technique and hydrostatic characteristic program, as shown in Fig. 26(c), through estimation of hull form through its drawings, prediction of ship weight and buoyancy distribution of lightweight and full-loading departure conditions and the information of each tank through Trim & Stability Calculation, and careful analysis of fuel oil and fresh water transfer just before sinking accident. These several estimation and prediction processes are very important for the accurate cause investigation of the actual flooding & sinking accident.

Full-scale ship flooding & sinking simulation was carried out, and sinking process and cause was analyzed for the precise and scientific investigation of sinking accident using highly advanced M&S system of FSI analysis technique. Figure 25(d) & (e) show the full-scale ship exterior & interior inflow procedures and sinking simulation behaviors in one of 3 cases, whose precise elapsed times could be predicted.

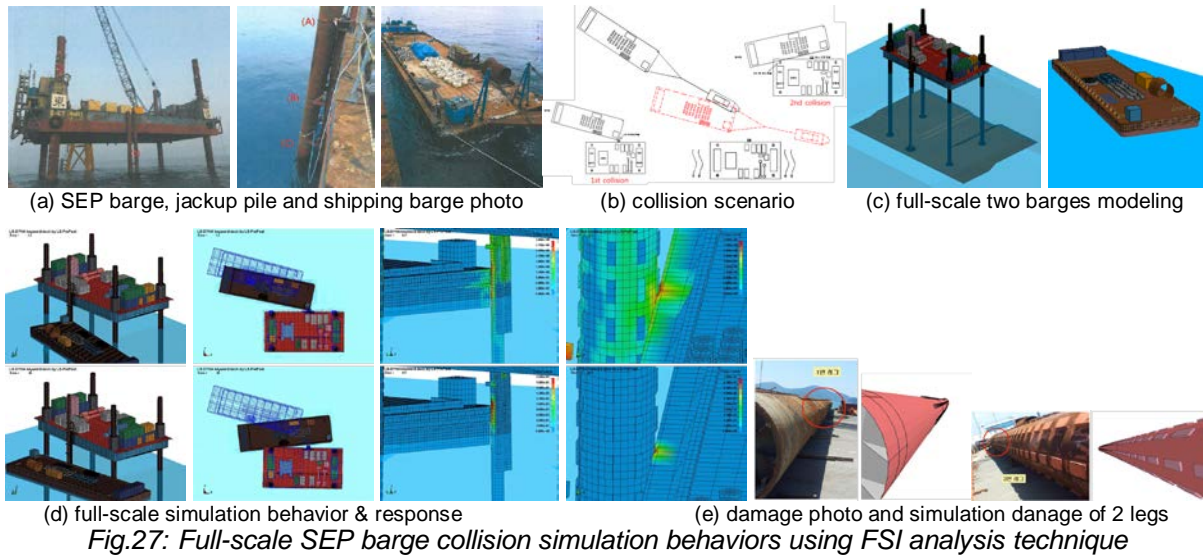
Jack-up pile of SEP(Self Elevated Pontoon) barge was collided very large at first, and then the 1st leg, slightly in the sea by the material shipping barge during coming alongside the barge, as shown in Fig. 27(a), where the 1st and 3rd legs were bent. Full-scale ship collision simulation was carried out using highly advanced M&S system of FSI analysis technique for the investigation of collision accident, figuring out the general shape, dimension and weight distributions of SEP barge and material shipping barge, and their detail structures through their drawings and photos, and submitted materials, estimating the sea bottom condition under the platform by comparing the total length of each leg and its topside one, and the leg housing structure mechanism for the restriction of top legs, predicting the collision simulation scenarios, as shown in Fig. 27(b), from the 1st and 2nd collision damages, and modeling full-scale ship and fluid (seawater and air), as shown in Fig. 27(c). Accurate cause investigation of collision accident was performed by the full-scale ship collision simulation, as shown in Fig. 27(d), and bent damage of legs was figured out, as shown in Fig. 27(e).

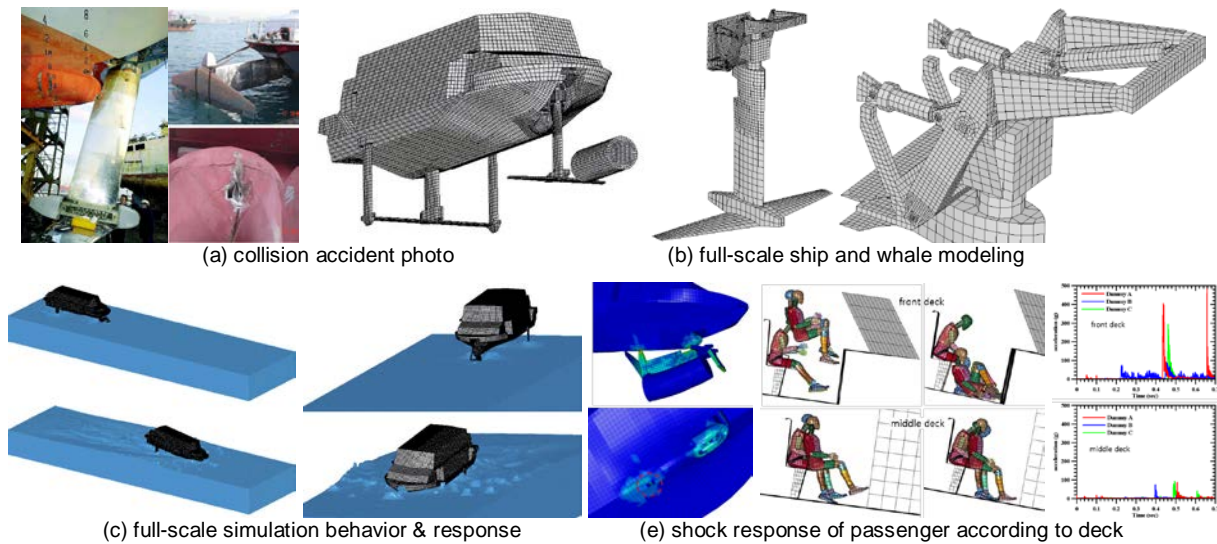
There happened several collision accidents of high speed passenger ship with underwater floating matters (whale), as shown in Fig. 28(a), where one passenger was died and a hundred ones, injured. Full-scale ship collision analysis of high speed passenger ship was performed with whales, as shown in Fig. 28(b) & (c), using FSI analysis technique for the cause investigation of collision accident, especially understanding of damage mechanisms due to the collision of its hydrofoil system with whale. Table 4 summarizes the material properties of aluminum alloy and stainless steel of high speed passenger ship and hydrofoil. Figure 28(d) shows the collision response behavior of passengers in the front and middle decks, and their acceleration responses according to deck position and dummy pattern. From this study, it could be confirmed that leverage of bulbous bow brought about more larger impact of foil & strut system to the ship structure and passenger, and led the bottom shell plate to be torn away and flooded. Seat belt was found to enhance the safety to the shock against the whale collision in the front deck.

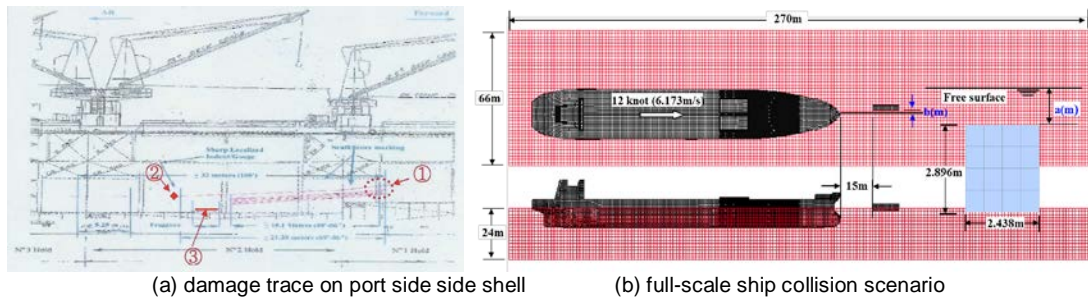
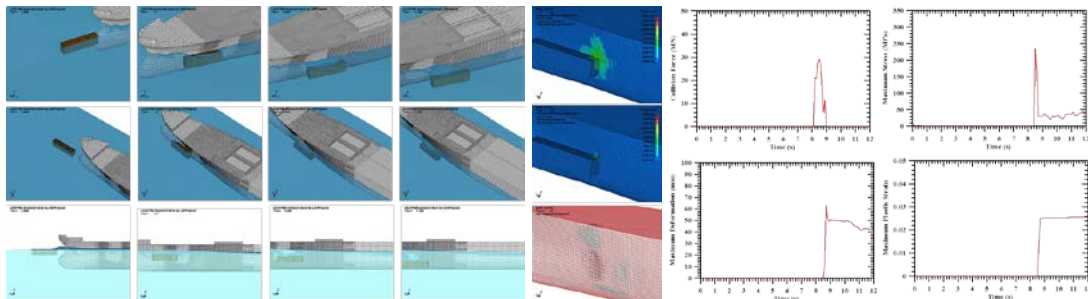
Fig.29: Full-scale bulk carrier collision simulation with container box using FSI analysis technique

Damage was reported on the side structure shell of bulk carrier due to the collision accident by the unidentified floating or submerged matters (40 ft high cube container box), as shown in Fig. 29(a), where there were two blow point traces, ① and ②, and a inclined trace band between two points ① and ②, and 3 cracks at the 7 ~ 8 mm upper part ③ from inner bottom. Two blow points ① and ② were located around at 4.5 m under the free surface and 2.5 m upon the point ③. Localized indent was also predicted at blow point ②.

From the full-scale ship collision simulation with container box according to collision scenario, as shown in Fig. 29(b), the following impact blow situations could be predicted. Floating container box on the free surface could be hardly collided to the bulk carrier bow side shell due to the wave making effect and squeezing pressure, and submerged container boxes, at 0.0 m ~ 0.1 m under the free surface and around 2.0 m off the longitudinal center line, as shown in Fig. 29(c), could be impacted only to the 1st blow point area and sunk down due to the very small buoyancy. There was no possibility for the 2nd impact and to the 2nd blow point, and also very small damage even at the 1st blow point area.
