# Marine Accident Integrated Analysis System using Highly Advanced M&S System of FSI Analysis Technique

Sang-Gab Lee, Jae-Seok Lee, Ji-Hoon Park and Tae-Young Jung

Korea Maritime & Ocean University, Marine Safety Technology, Busan, Korea

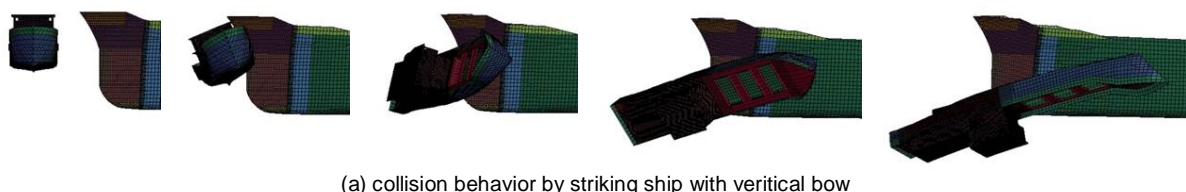
Fig.8: Full-scale ship collision & capsizing simulation behaviors in void condition

Figures 8 and 9 illustrate the full-scale ship collision & capsize simulation behaviors and collision damage responses (stress responses) of struck fishing vessel using void condition with initial velocity against the cargo ships with vertical and bulbous bows, respectively. It could be found that collision damages of struck fishing vessel look like unrealistic and different depending on the bow types of striking cargo ships, and that their simulation damages are not similar to the real damage one, as shown in Fig. 5(c). Fishing vessel was rebounded downward right after collision to the inclined bow flare, since there was no buoyance in the void condition. While the bottom of fishing vessel was collided to the top of bulbous bow of cargo ship and then rebounded upward, the low side shell plate of fishing vessel was collided along to the vertical bow of cargo ship. All damage of fishing vessel was followed by its collision behavior according to the bow type of cargo ships. It could be found that more accurate and realistic collision behaviors could be realized using FSI analysis technique.

(a) collision behavior by striking ship with vertical bow

(b) collision behavior by striking ship with bulbous bow

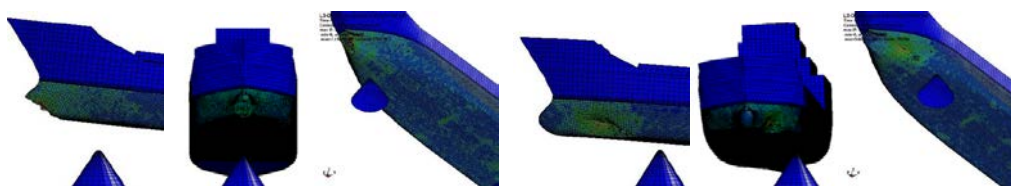
Fig.11: Grounding response behaviors at free motion condition according to rock position in void

Figures 11 and 12 show the full-scale ship grounding simulation behaviors, with two rock positions, center of and 3.0m off the longitudinal center line, at free motion and plan constraint conditions in void, respectively. Contrary to the case of FSI analysis technique, it could be confirmed that grounding simulation behaviors and bottom damage in void conditions were very unrealistic.

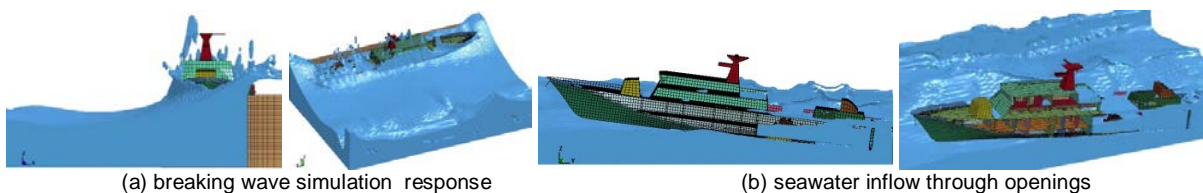
Fig.20: Breaking wave simulation behaviors & seawater inflow through openings of deck and superstructure

Due to very large computational time in this full-scale ship flooding & sinking simulation using FSI analysis technique, the simulation was carried out by three steps. At the first step, the ship showed more or less complicated motion of heaving, rolling and surging, and air fenders, also heaving and surging, as shown in Fig. 20(a). Even though the breaking wave escaped through the gaps in the bulwarks, a lot of seawater was still gathered on the deck surrounded by the bulwarks. It could be found that seawater flowed into the several openings of the deck and through the openings of the superstructure, and that the engine compartments became flooded gradually, as shown in Fig. 20(b).

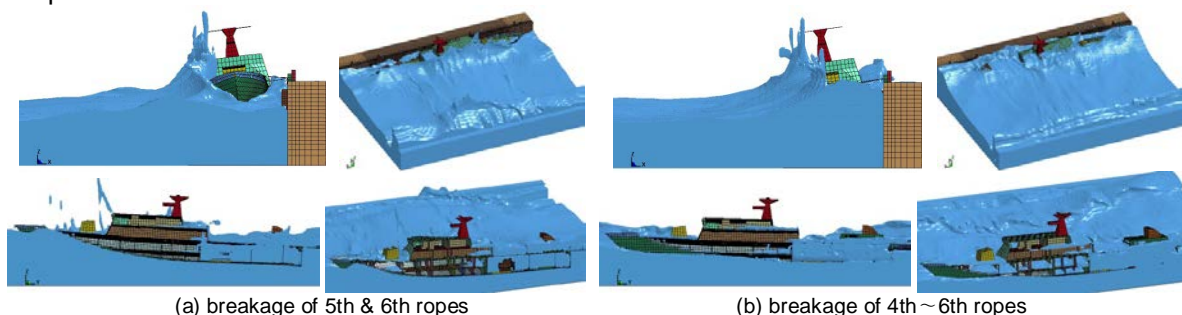
Fig.21: Breaking wave simulation behaviors with breakage of ropes, seawater inflow & propagation

Figure 21 shows the breaking wave simulation behaviors to the ship and quay, and ship motion ones, depending on the breakage of the rear ropes at the second step. As the seawater flooded in the inboard of ship, the rear of the ship trimmed by the stern more and moved more vertically and laterally, and the 5th, 6th and 4th ropes were cut off one by one with the increase of their tensile strengths, where the rear of the ship rolled out more to the starboard. Seawater flowed inside through the doors of superstructure and the openings of deck, and propagated through the openings of watertight bulkheads to the accommodation compartments. Breaking wave also swept over the forecastle deck and seawater also flowed inside through the openings of forecastle deck into the inboard compartments.

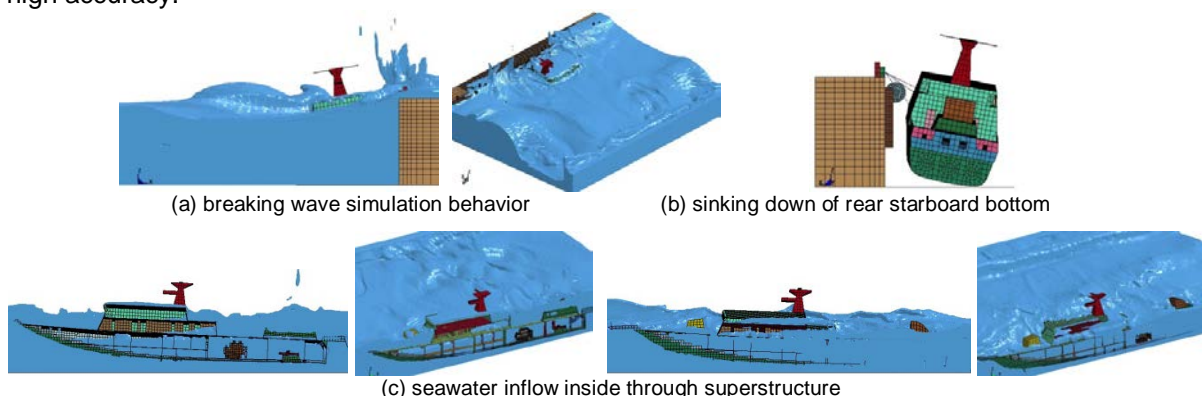
Fig.22: Breaking wave simulation behaviors, seawater inflow through doors & sinking down to bottom

At the final step, Fig. 22 shows the breaking wave simulation behaviors to the ship and quay, where the ship sank down more and rolled out more to the starboard. After seawater was flooded into the most compartments under the main deck, seawater flowed inside through the doors of superstructure, and the ship sank down more and the rear starboard bottom touched to the bottom. Through the full-scale ship flooding & sinking simulation using FSI analysis technique and realizing the rough sea condition, such as breaking wave, flooding and sinking accident procedure could be investigated with high accuracy.

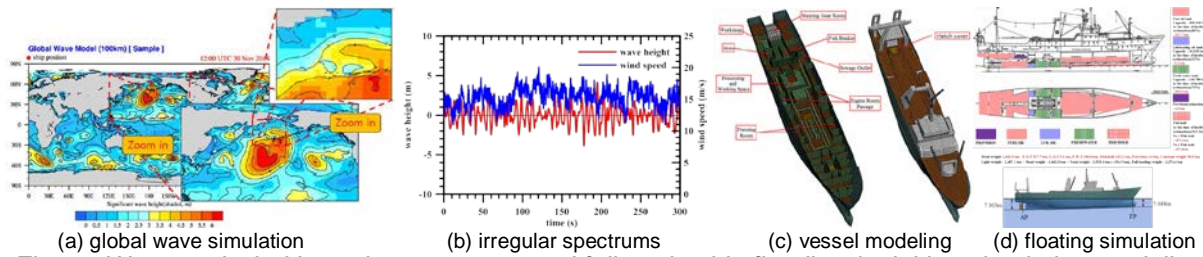
Fig.23: Wave and wind irregular spectrums and full-scale ship flooding & sinking simulation modeling

For the objective secure of weather and sea states in the Bering Sea, time-based wave and wind simulation at the region during sinking accident was carried out, as shown in Fig. 23(a). Sea and weather states were realized by simulating the irregular strong wave with significant wave height 4.5m & period 8.0sec, and irregular strong wind with wind speed 15.0m/sec, as shown in Fig. 23(b). Full-scale ship and fluid (air & seawater) modeling was performed for flooding & sinking simulation, investigating the hull form, structural arrangement & weight distribution through its drawings, figuring out the exterior inflow openings, interior flooding paths, as shown in Fig. 23(c), and the weight distributions of fish catch, fuel oils and their tanks through the stability calculation, and estimating the main tank capacity by its drawings and stability calculation and predicting their loading status by the daily report, as shown in Fig. 23(d).

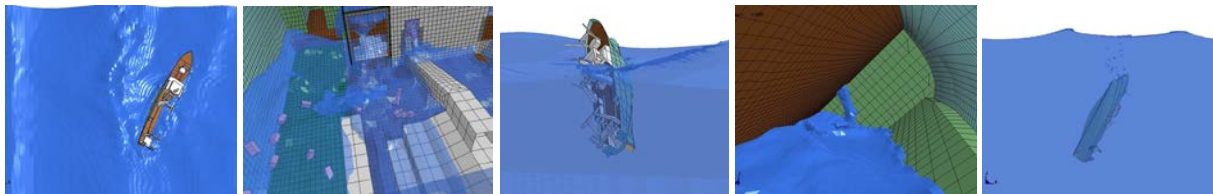
Fig.24: Full-scale deep-sea fishing vessel flooding & sinking simulation behaviors

Full-scale ship flooding & sinking simulation was carried out for the seawater inflow through the exterior openings, hatch cover and sewage outlet, and through the interior paths along the compartments, processing & working space, engine room and fish holds together with the inclination to the starboard and port sides, the submergence of the stern under the surface, and the sinking to the bottom, greatly by two scenarios, as shown in Fig. 24.

It could be confirmed that the accident ship was flooding and sunk down from the full-scale ship flooding & sinking simulation behaviors using FSI analysis technique with a little bit different situation from the general capsized and sinking accident due to the simple loss of stability, in that the stern part subsided under the surface with the center of gravity descended a little bit down due to the seawater inflow in the engine room and fish holds, and with continued large angle of heel at the same time of submerged stern part under the surface even though its heel was progressed greatly.

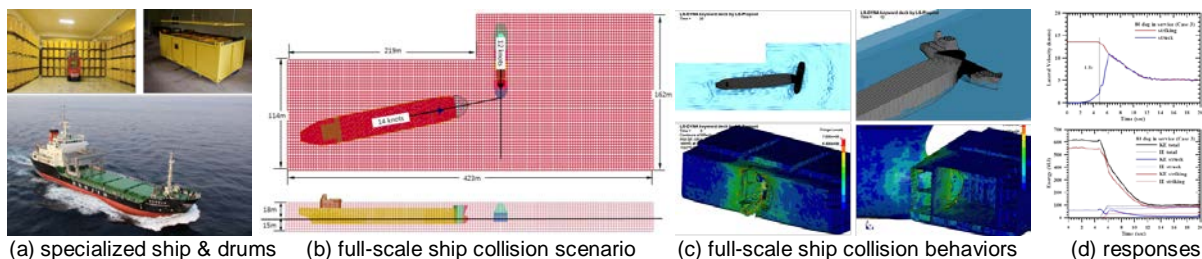
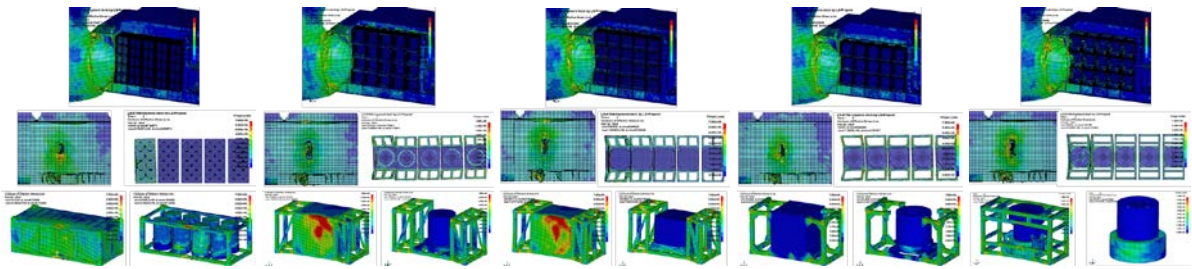
Fig.30: Full-scale specialized ship collision simulation with container box &amp; drum using FSI analysis technique

Structural safety assessment was performed for the collision accidents of specialized ship structure and its cargo drums with DWT 2,600 ton, as shown in Fig. 30(a), using FSI analysis technique. Diverse scenarios were tried for the conservative safety assessment, such as several collision angles and 5 striking ship sizes from DWT 500 to 35,000 ton, and cargo container boxes and drums were also loaded inside the cargo hold of struck ship. Figure 30(b) & (c) typically show the collision scenario, simulation behaviors of DWT 35,000 ton striking ship, where striking ship collided to the front of its 3rd cargo hold in service at 80 degree attack angle, and Fig. 30(d), collision responses of lateral velocity, kinetic and internal energies of striking and struck ships.

Full-scale ship collision simulation was carried out again for the structural safety assessment of cargo container boxes and drums, as shown in Fig. 30(e), where fracture damage in the side inner hull of struck ship was greatly reduced to a small rupture by the crashworthiness of container boxes and drums. It could be found that damage patterns were different according to the type of container box and drum. The specialized ship was also found to be superior to the crashworthiness of ship collision due to the wide double side hull space. There was no damage in cargo drums, and container boxes also greatly contributed to the crashworthiness of side structure.
