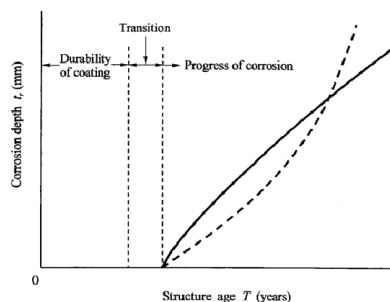
Figure 5: Stages of corrosion process [6]

Atmospheric corrosion is one of the major ageing effects on structural steels. In general, if the steels are not protected properly, corrosion develops gradually through time. *Figure 5* shows that coating protects the steel for some time. After the end of the coating lifespan and transition period, corrosion damage starts to develop. The concave and convex curve representing acceleration or deceleration of corrosion rate, respectively. A linear approximation is often used to simplify the analysis.

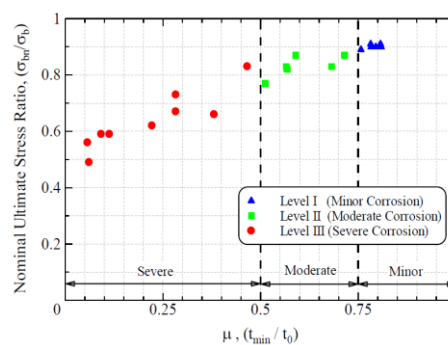
Figure 7: Nominal Ultimate stress Ratio vs. thickness ratio [8]

The relationship between corrosion severity and mechanical properties deterioration is illustrated in ratio in Figure 7. Basically it shows how mechanical strength of the steels decrease when the level of corrosion becomes worse [8].

2. By extrapolating the relationship between mechanical properties deterioration and steel thickness reduction as in *Figure 7*, remaining yield stress is 70% for upper frame, 65% for side frame and 60% for lower frame, bus skin and non-structural parts.
3. Major parts like engine, drive shaft and gear box maintain their original properties.
4. Welded joints of structures are assumed to remain intact and maintain its original properties.

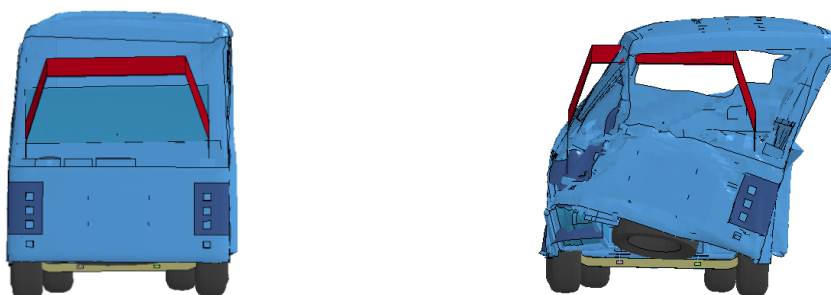
Figure 11(a): New bus condition after rollover Figure 11(b): Aged bus condition after rollover

Figure 11(a) shows the condition of a new bus after rolled over. The overall structure is generally remained intact and residual space envelope is not penetrated, so it passed the test. Figure 11(b) shows the condition of aged bus after rolled over, whereby the upper structures are clearly penetrating the residual space. Hence the test for the aged bus is obviously failed.

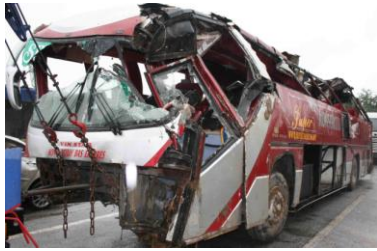
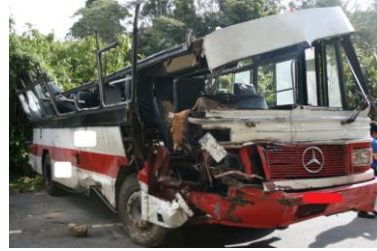
Figure 12(a): Service age is 4 years [11] Figure 12(b): Service age is 20 years [12]

From real-world crash investigation of bus roll-over in Malaysia, it can be seen that there are some degree of similarities of structural deformation between real-world roll-over crash and simulation. This can be observed in Figure 12(a) and Figure 12(b). The superstructure condition in Figure 12(b) which the service age is 20 years is worse than that in Figure 12(a), which the service age is 4 years.

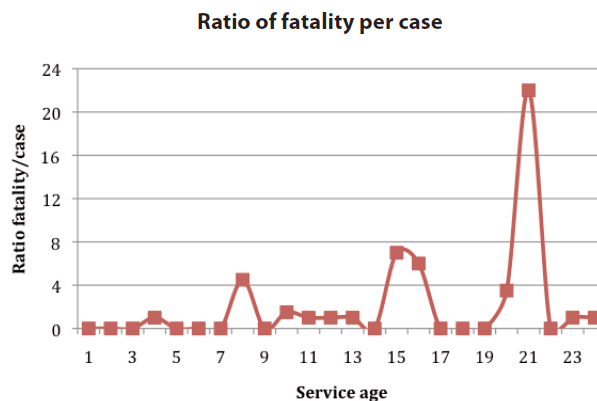
Figure 13: Ratio fatality/case vs. service age

In [13], number of fatality per each bus crash case is plotted against service age of the bus, as in Figure 13. The methodology to obtain this statistics will not be discussed here. Generally, it can be observed that there exists relationship between increase of fatality number in a crash with the increase of bus service age.
